Diagnose Snelkoppelingen – 80 reeks (ISO 15171-1) Coupleur Rapides Diagnostiques – série 80 (ISO 15171-1) Diagnostic Test Point Couplings – 80 series (ISO 15171-1)

DIAGNOSE | ISO 15171-1

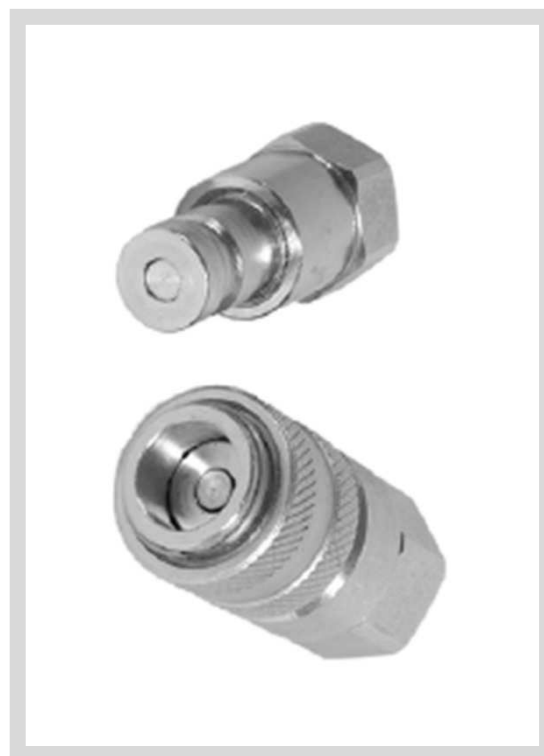
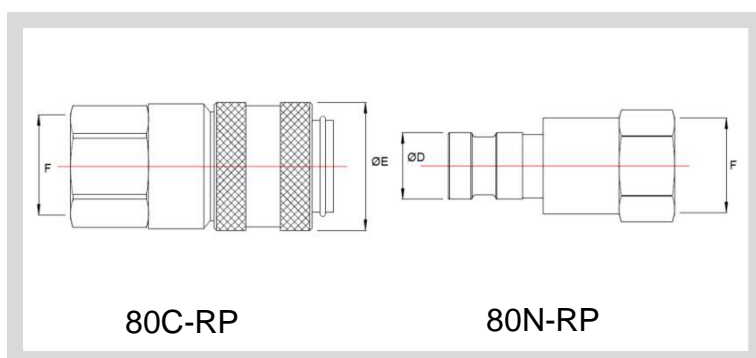
Diagnostic test point coupling:

- ~ Flatface safety locking sleeve
- ~ Pressure testing on hydraulic circuits
- ~ Manufactured in carbon steel, heat treated, zinc nickel plated, NBR seals (-25°C to +100°C)

Vrouwelijk Femelle Female	Mannelijk Mâle Male	DN	F	ØE	ØD
